ELEMENT INSPECTIONS, LLC.

Home Inspection Report

June 29, 2005

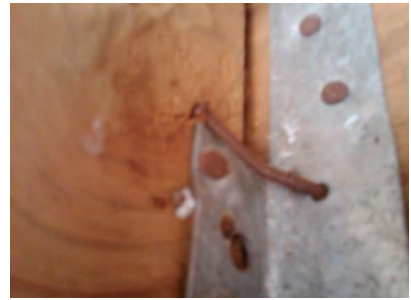
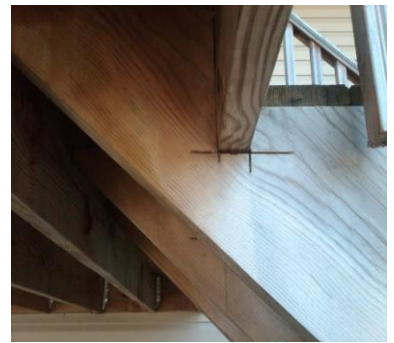
Deck needs some structural repairs to improve safety.

- 1) Add joist hangers to two joists. 2) **Safety issue** - joist hangers are nailed with non galvanized, under-sized nails. 3) **Safety issue** – block between joists at rail post locations to stabilize rail.
- 4) **Safety Issue** – add mechanical fastener to top of stair (stringer could split over time causing stair to become unsafe).

- 1) ADD JOIST HANGERS TO TWO JOISTS WHERE THEY ARE MISSING.....Page 5
- 2) REPAIR OR REPLACE HANGERS THAT HAVE IMPROPER NAILS.....Page 5
- 3) BLOCK BETWEEN JOISTS TO STABILIZE RAIL ON DECK.....Page 5
- 4) FASTEN TOP OF DECK STAIRPage 5

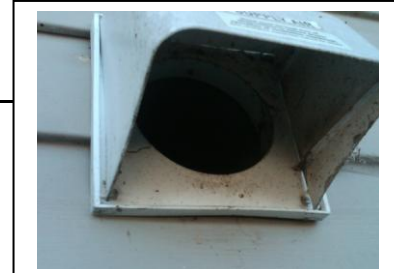
Maintain: A missing air intake screen was observed. The vent screen should be replaced to prevent vermin entry.

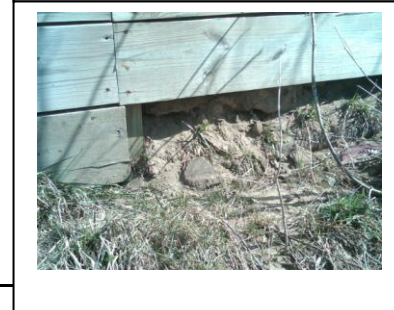
Maintain: The back side of the pole building has boards holding the soil underneath the floor slab of the barn, there are areas where the soil is exposed. Rain could wash out this soil over time, causing voids under the floor. This should be closed off to prevent this.

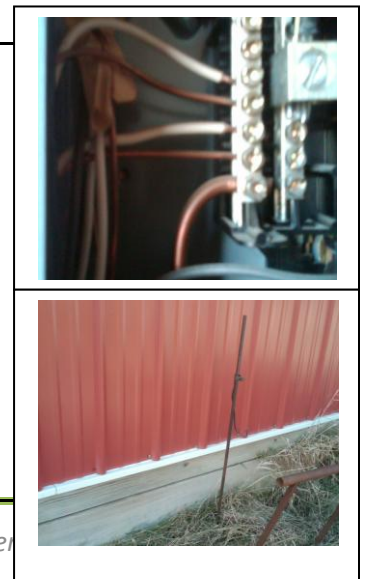
5) **Repair:** Sub-panel in pole building has grounded neutral wires and a grounding rod that is not buried deep enough. This has the potential to be a safety issue and should be repaired.

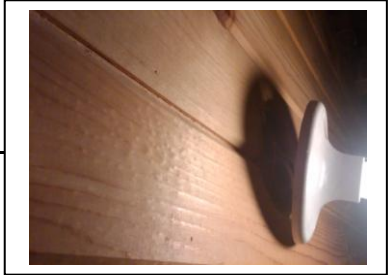
Improve: The vanity light in the basement bath is loose and should be tightened.

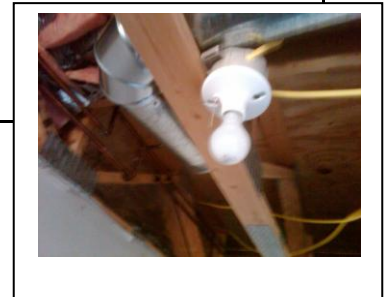
Improve: The pull chains on the basement lights should have non-conductive leads to remove the risk of electric shock due to a short in the fixture.

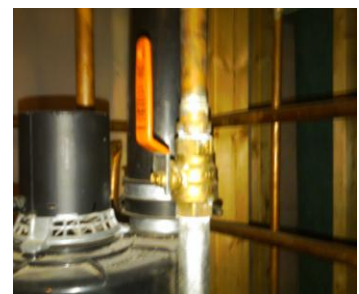
Improve: There are dielectric connections (copper pipe connected directly to steel pipe) on the water heater. This can cause premature corrosion, especially on the hot water side. A connector with a plastic insert can be installed to prevent this.

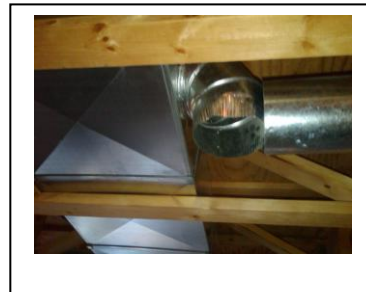
Improve: The only source of heat for the downstairs rooms is radiant in floor. Heat supply runs and returns can be added to provide heat through the gas furnace.

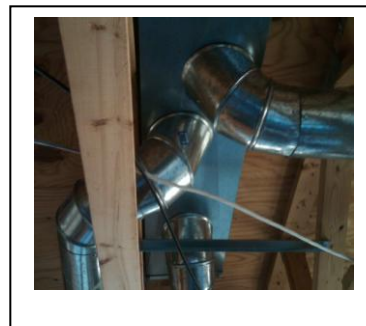
Improve: The heat supply duct for the upstairs entry is disconnected. This should be reconnected.

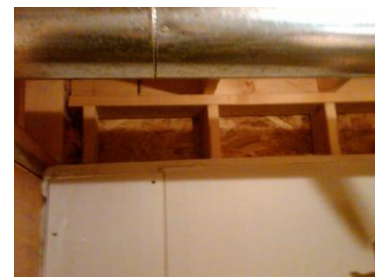
Improve: There is no insulation on the short wall under the entry.

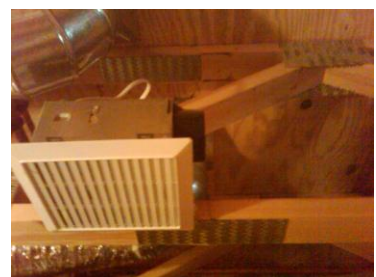
Improve: The basement bath fan has no exhaust vent leading to the exterior.
